Water Quality in the Los Angeles River:
A Remote Sensing Based Analysis

A Thesis Presented to the
FACULTY OF THE USC DORNSIFE COLLEGE OF LETTERS, ARTS AND SCIENCES
University of Southern California
In Partial Fulfillment of the
Requirements for the Degree
MASTER OF SCIENCE
(GEOGRAPHIC INFORMATION SCIENCE AND TECHNOLOGY)

May 2023

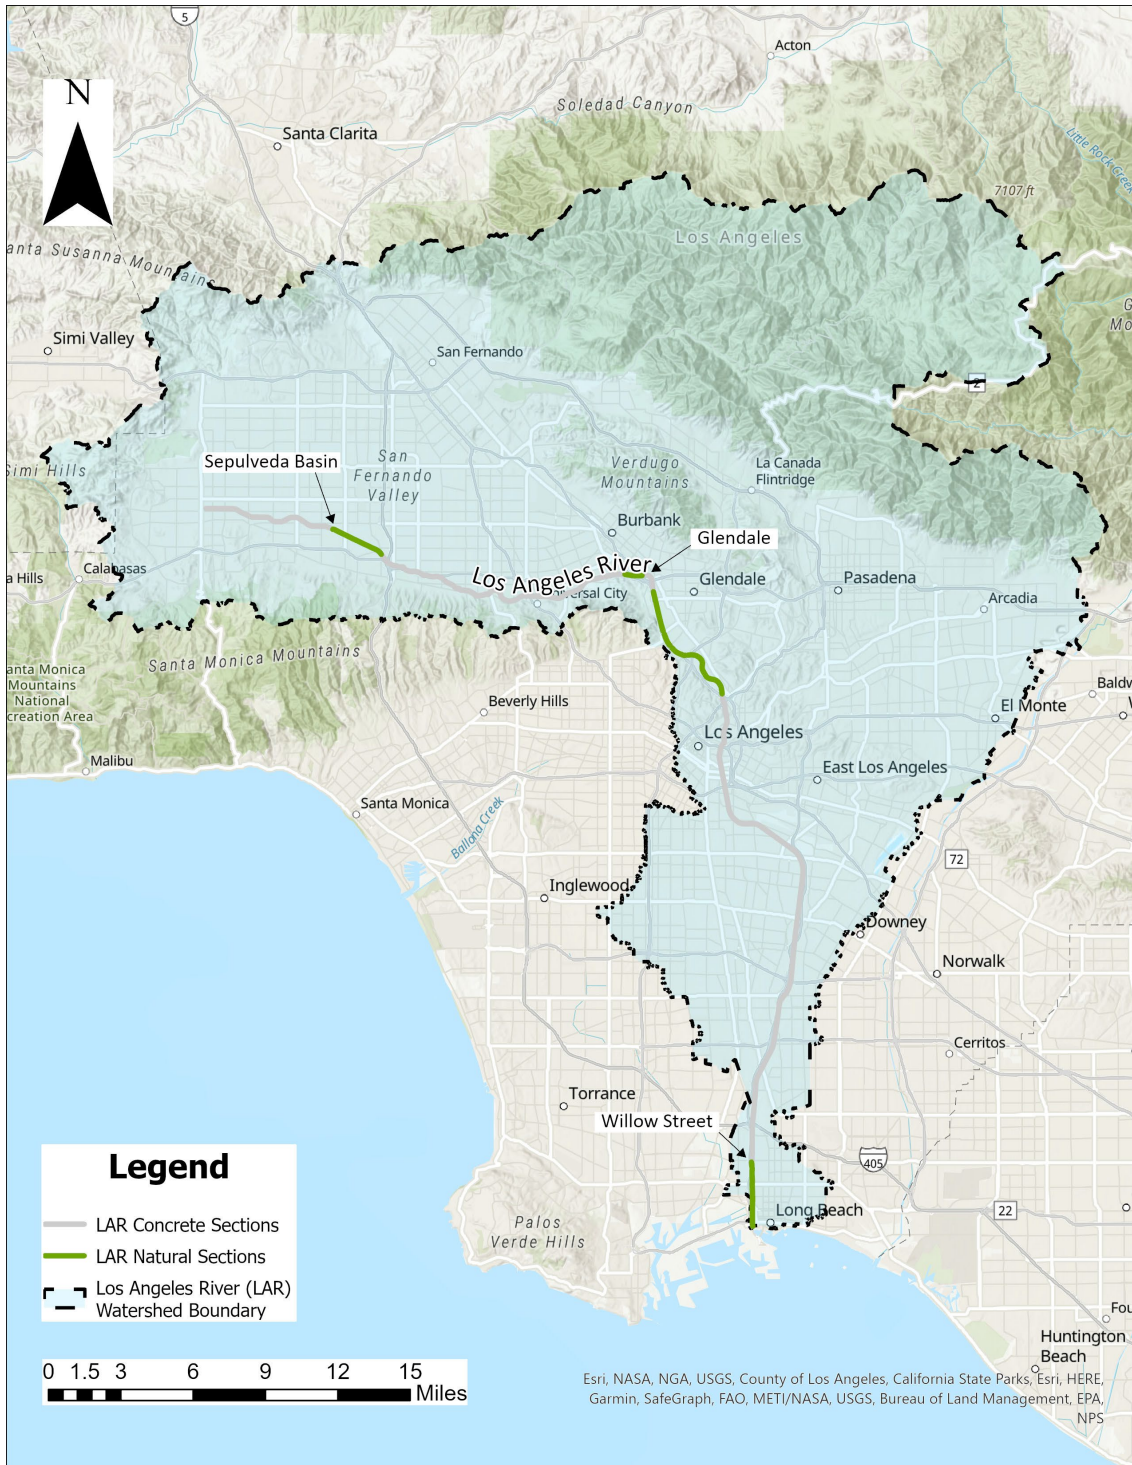
Figure 2. Concrete and natural reaches of LAR

As more people settled into Los Angeles the region shifted from an agricultural landscape to an urbanized cityscape. As development encroached into the broad floodplain of the LAR in the 19th and 20th centuries, storms produced massive flows that caused loss of life and millions of dollars in property damage (U.S. Army Corps of Engineers Los Angeles District 2015). The culminating event that spurred the mass construction project that produced the channelized version of the LAR today was the Flood of March 1938. The peak flow of the LAR during the 1938 flood was greater than the average flow of the Mississippi River at St. Louis and the flood water led to 45 deaths and \$17 million dollars in damages (Gumprecht 2001). The first flood control projects began shortly after 1938 flood and continued until 1970 (Gumprecht 2001). The character of the river has changed dramatically with 94 percent of the LAR having concrete banks and three quarters of the river's course being fully concreted (Gumprecht 2001). Concrete and natural riverbed reaches of the LAR are shown with locations of sample frames used in this study in Figure 2.

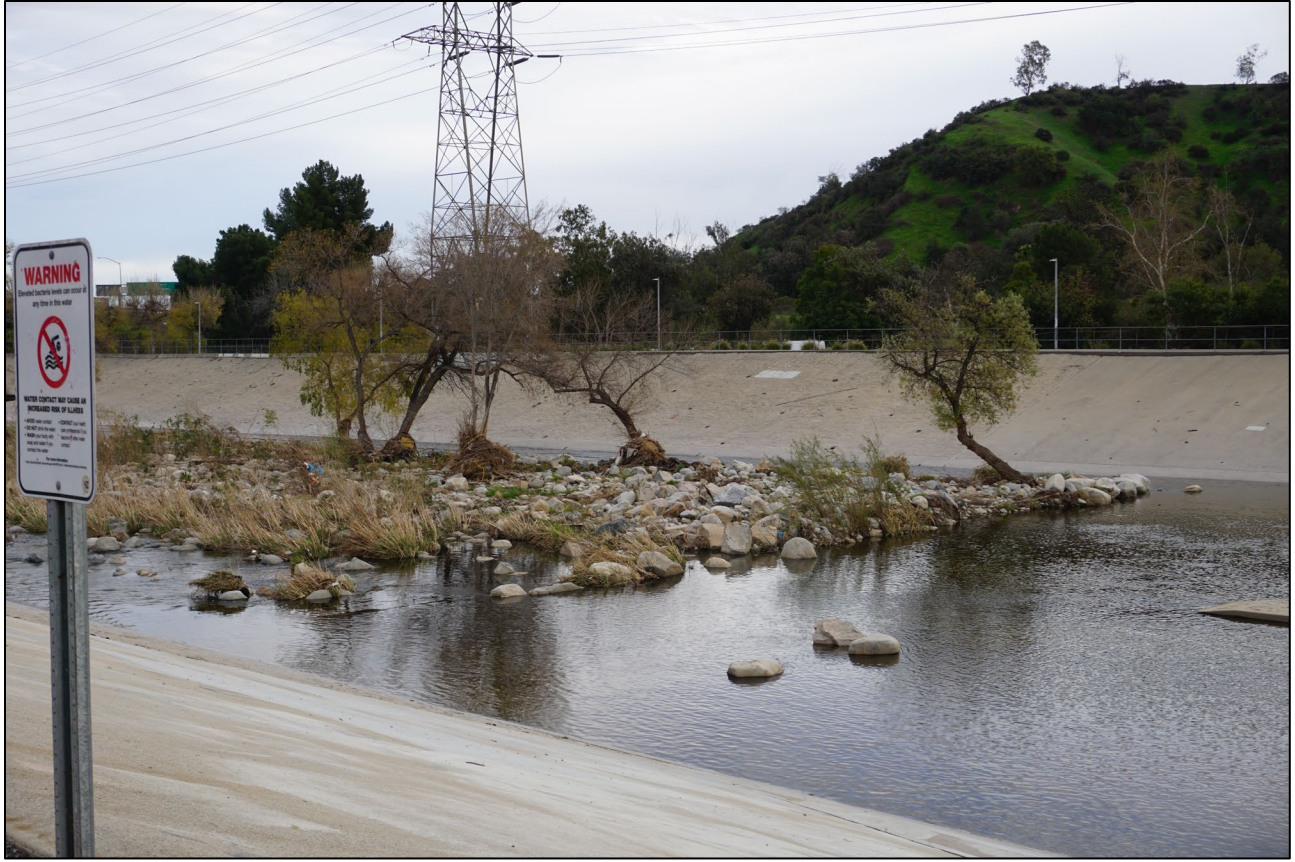
Figure 3. Section of natural bottom riverbed adjacent to the Glendale Narrows Riverwalk.
Author January 2022.

For the LAR downstream of the spatial limits of the USACE study and restoration area, a Draft Program Environmental Impact Report (LAPIER) was prepared by ICF International Inc. for Los Angeles County Public Works. This report concluded that a restoration alternative of implementing a natural riverbed while maintaining the current engineered channel configuration would increase flood risk and not improve water quality and therefore was eliminated from project plans (ICF International Inc. 2021). This assertion appears to contradict the USACE-conducted study upstream which is used sections of semi-natural LAR in Glendale as an example for future restoration efforts. Portions of the Glendale reaches of the river are composed of a natural riverbed within an engineered channel in which natural hydrologic processes persist and flooding events are controlled. The USACE expects similarly designed future restoration areas to have the same behavior (U.S. Army Corps of Engineers Los Angeles District 2015). An example of this area can be seen in Figure 3.

The Glendale Narrows is a working example of a hybrid natural/engineered river channel providing adequate flood protection while maintaining a functioning riparian habitat (U.S. Army Corps of Engineers Los Angeles District 2015 ES-4). A remote sensing-based approach to observe this area and several other study sites along the LAR can provide evidence to test the conclusion found in the LAPIER report from 2021 regarding any naturalized channel restoration efforts being unfeasible. Specifically, a remote sensing-based methodology which focuses on comparing water quality in natural and concrete riverbed reaches of the LAR can illustrate the benefits of environment services provided in the semi-natural stretches of the river.

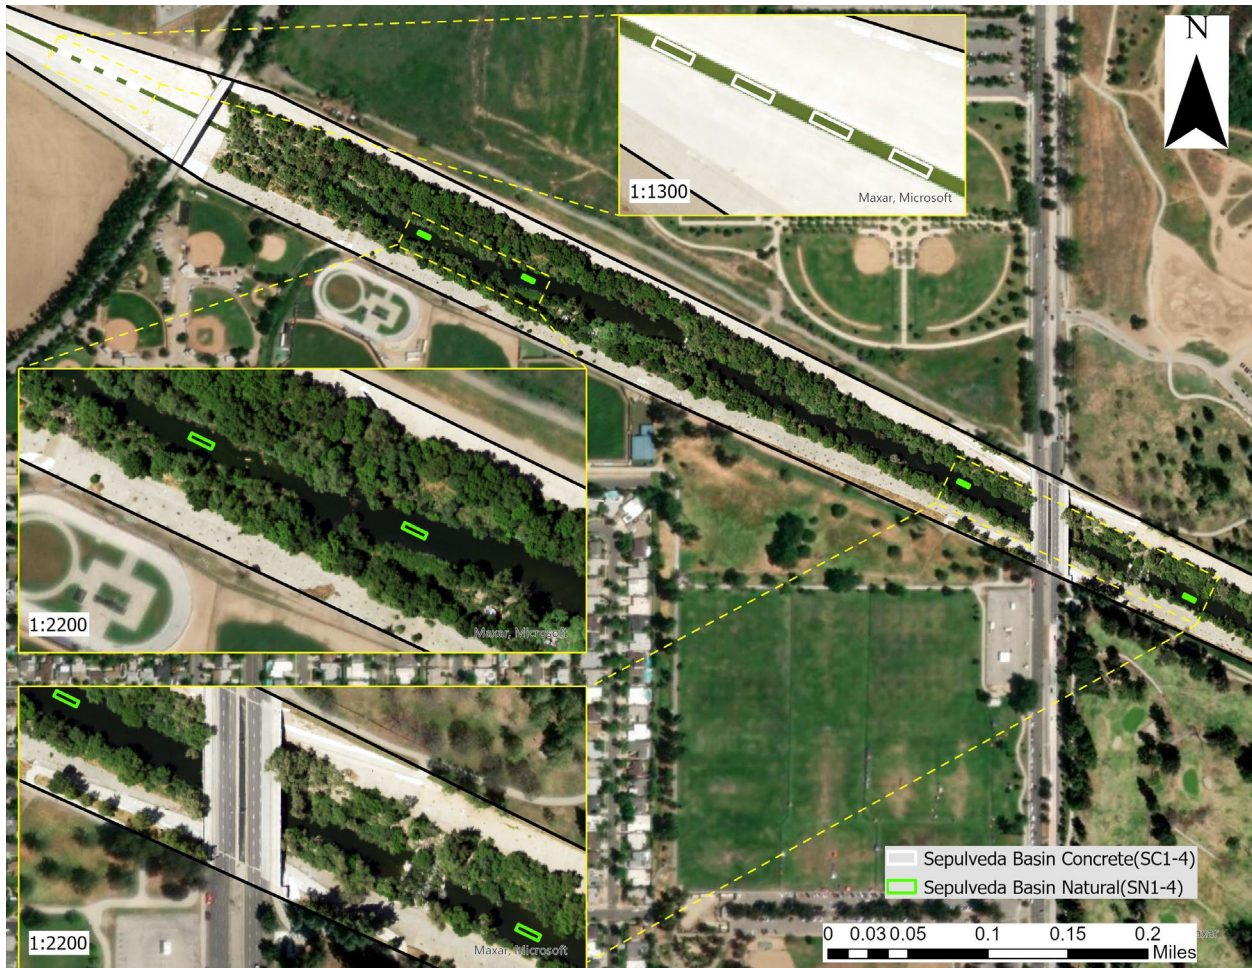
Figure 5. Sepulveda Basin sample frame

In the Sepulveda Basin sample area, a shallow trapezoidal concrete channel approximately 14 feet wide containing water transitions into a natural riverbed containing relatively deep slow moving water surrounded at its banks with thick vegetation. All sample sites occur upstream of any major surface water confluences in the Sepulveda Basin; however, the final natural sample site (SN4) lies 600 ft upstream of Bull Creek within a stretch of water

Sample Polygon and Key Features	Distance (ft)
SC1	0
SC2	84
SC3	166
SC4	250
Concrete to Natural Riverbed Transition	615
SN1	1330
SN2	1703
SN3	3292
SN4	4128

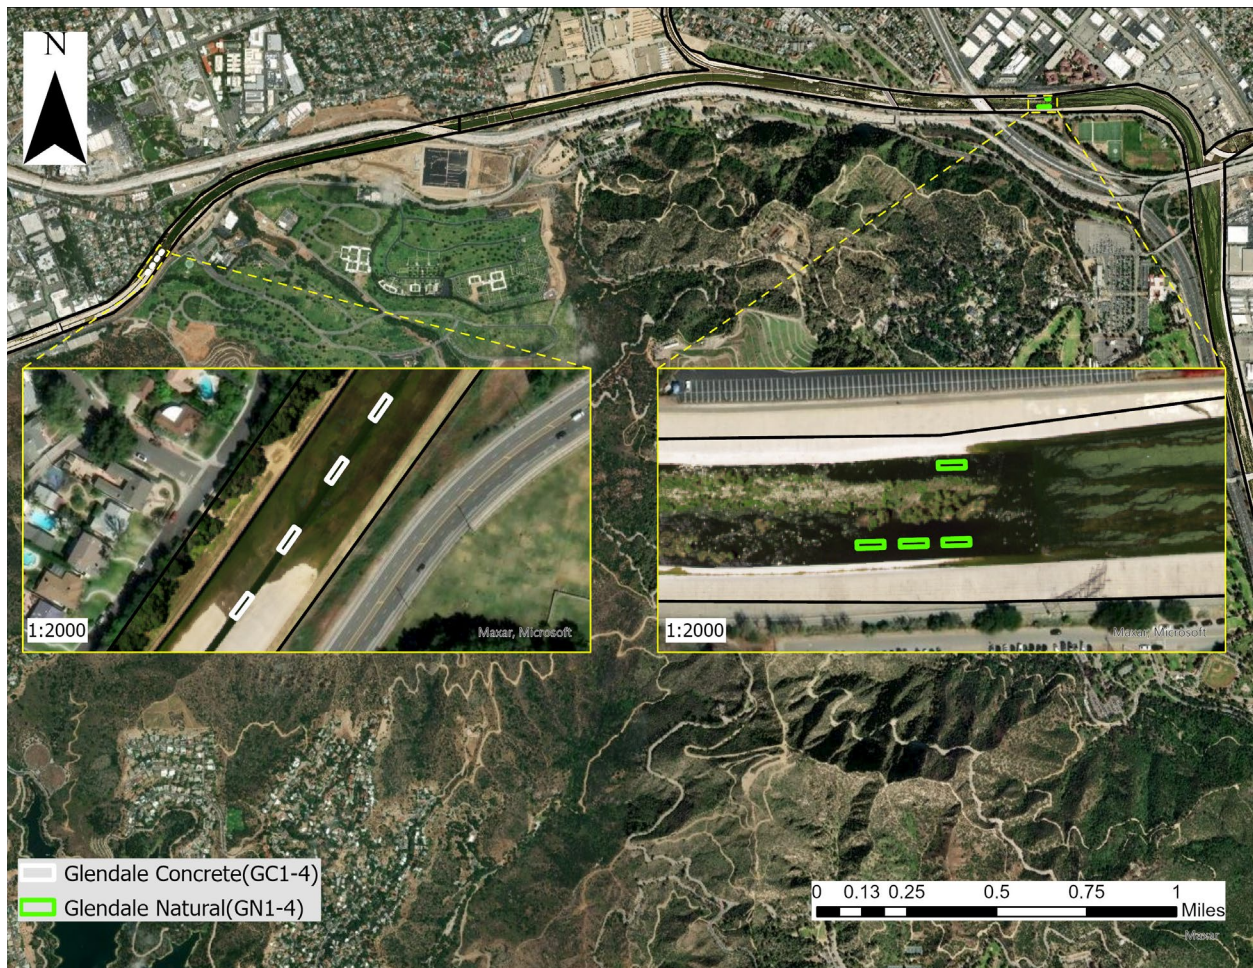
Figure 6. Glendale sample frame

Sample Polygon and Key Features	Distance (ft)
GC1	0
GC2	119
GC3	242
GC4	355
West Burbank Channel Confluence	9792
Concrete to Natural Riverbed Transition	10342
Natural to Concrete Riverbed Transition	12038
Concrete to Natural Riverbed Transition	12368
GN1	13884
GN2	13948
GN3	14003
GN4	14011

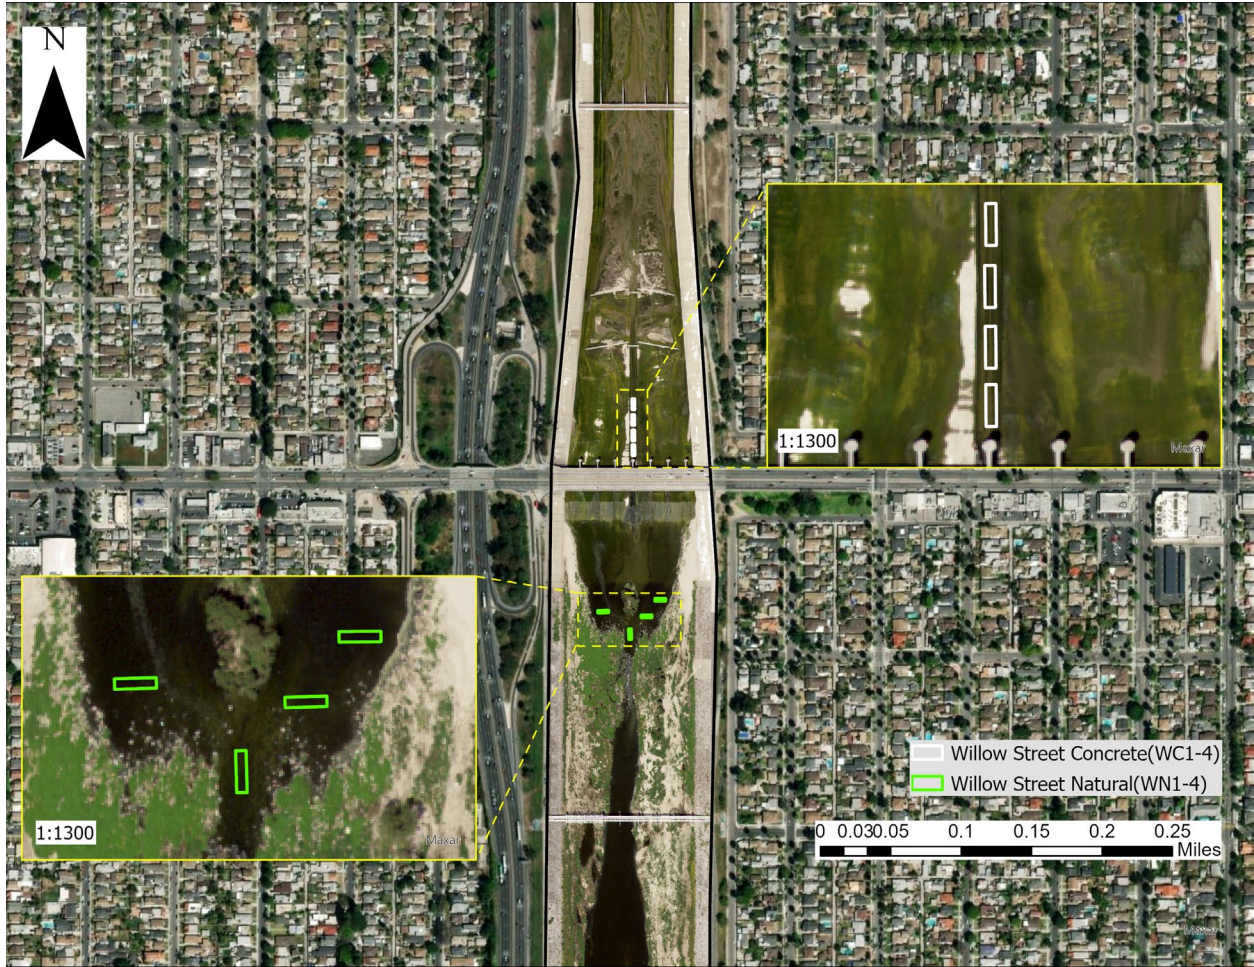
Figure 7. Willow Street sample frame

Sample Polygon and Key Features	Distance (ft)
WC1	0
WC2	59
WC3	117
WC4	172
Concrete to Natural Riverbed Transition	686
WN1	746
WN2	789
WN3	810
WN4	861

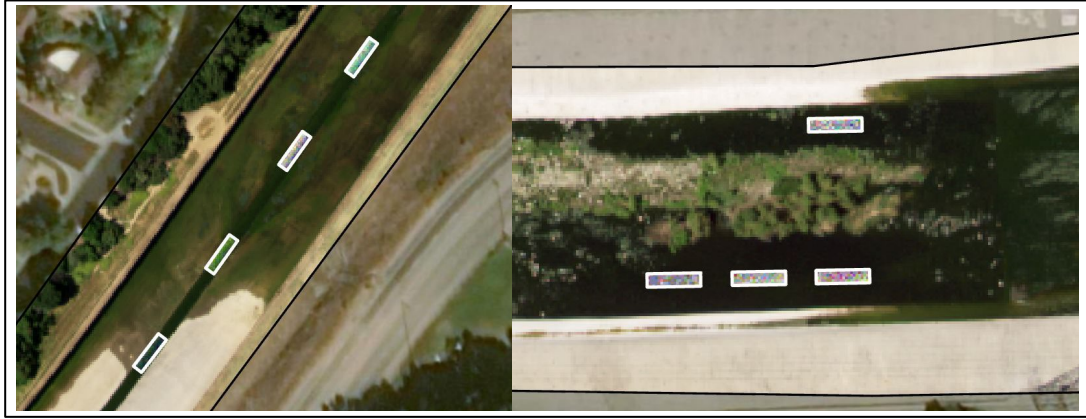
Figure 9. Glendale sample frame. Left: concrete riverbed sample. Right: natural riverbed sample. NAIP Imagery (U.S. Geologic Survey 2021). Sample area rasters produced in ArcGIS Pro.

Raster images clipped with uniform polygons can be seen below in Figure 9.

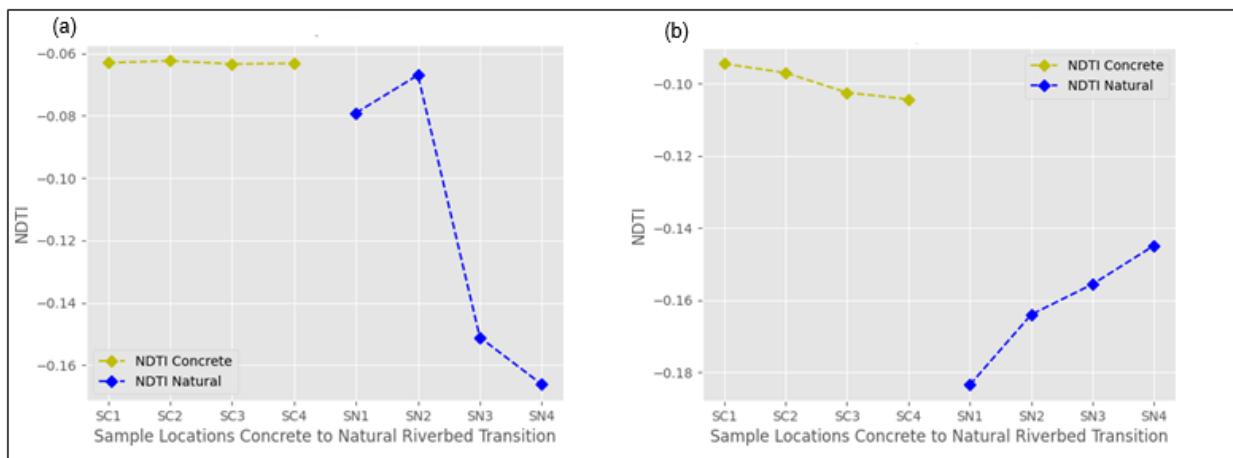
Figure 10 Sepulveda Basin NDTI: (a) 2018 and (b) 2020.

Within the Sepulveda Basin turbidity was observed to be of lower concentration in natural sample sites as opposed to concrete sample sites for all data points collected. In comparing physical characteristics of the other sample frames in the study, Sepulveda Basin contains the longest stretch of natural riverbed, is heavily vegetated, and contains slow moving water. Vegetation has an attenuating effect on turbidity intensity in waterbodies. Moreover, there are no WRPs upstream of the sample sites at this location that would influence hydrochemistry. The DTCWRP discharges treated water into the LAR downstream of the sample sites and is separated by a rudimentary dam. The features of the Sepulveda Basin make it the most ideal sample frame in this study for comparing turbidity in concrete and natural riverbed stretches.

The final sample site (SN4 in Figure 10) in the natural riverbed section is close to the confluence with Bull Creek. SN4 is isolated on a stretch of the LAR between two dam like structures and Bull Creek discharges into the same stretch. It is possible the creek could influence the NDTI levels near the SN4 sample site. Bull Creek has been observed to exceed water quality objectives for turbidity set by the California Department of Water Quality Control Board in wet and dry seasons (Weston Solutions, Inc. 2005). In the 2020 NDTI results the highest natural riverbed turbidity value was located at the SN4 sample site whereas the 2018 NDTI result at the same site recorded the lowest turbidity which is indicative of the highly dynamic nature of turbidity within a river system.

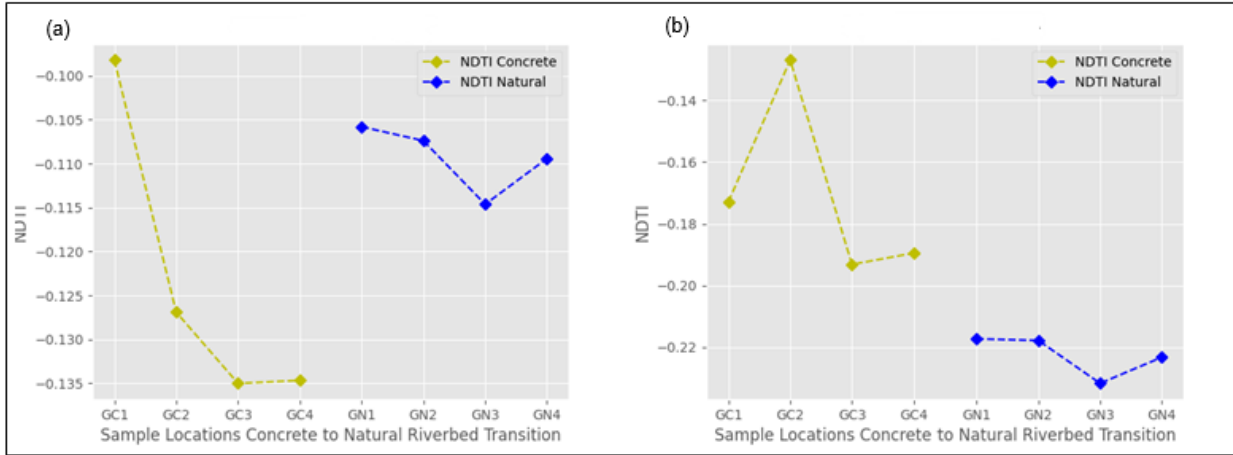
Figure 12. Glendale NDTI: (a) 2018 and (b) 2020.

The NDTI results for the Glendale sample frame were not as uniform as expected. The 2018 NDTI results shown in Figure 12 show that the turbidity levels in the natural riverbed sample sites were all higher than any of the turbidity levels in the upstream concrete sample sites. The elevated turbidity values in the natural riverbed samples in 2018 could be attributed to the unique characteristics the Glendale sample frame. The BWRP discharges treated wastewater into the West Burbank Channel roughly two miles upstream, and constituents discharged by the BWRP may contaminate the river by adding partially treated effluent into the system (Boroon & Coo 2015). The concrete sample sites in the Glendale sample frame were collected upstream of the West Burbank Channel and LAR confluence and therefore the hydrochemistry was affected by this source. The 2020 NDTI results for Glendale indicate the turbidity was lowest in the natural riverbed sample sites (Figure 12b).

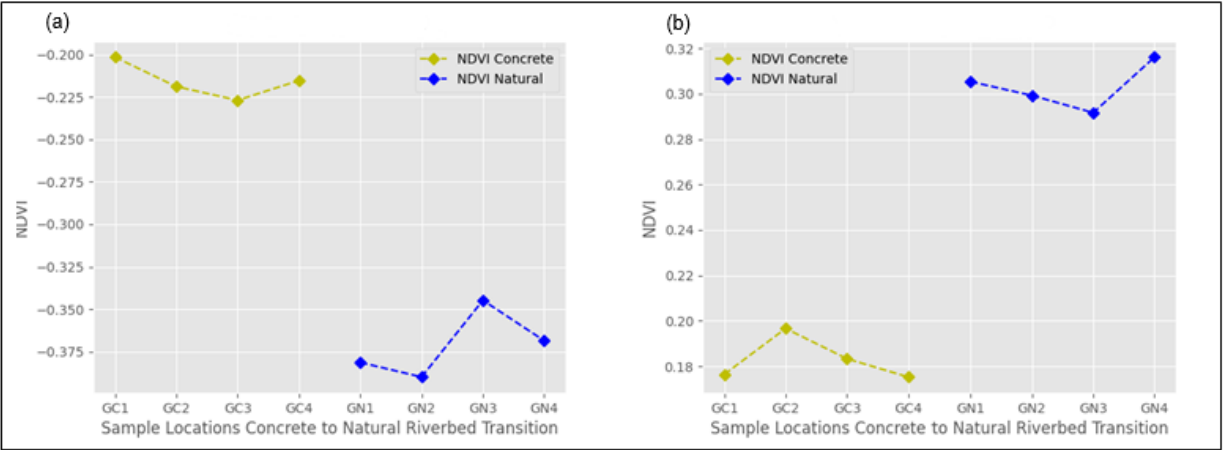
Figure 13. Glendale NDVI: (a) 2018 and (b) 2020.

Similar to the NDVI results in Sepulveda Basin, the results for the Glendale sample frame are split. At Glendale chlorophyll-a concentrations declined in the concrete to natural riverbed transition in 2018 but increased in 2020. Unlike the Sepulveda Basin sample frame, the natural riverbed section sampled at Glendale is influenced by an upstream WRP. The highest nutrient levels in the LAR have been observed downstream of WRPs (Stein and Ackerman 2007). Since the concrete sample sites at Glendale occur upstream of the inlet channel connected to the BWRP, they are not influenced by the same constituents as the natural riverbed sites. In addition, the intermittent nature of WRP discharges creates fluctuating hydrochemistry downstream of any outlet. In any circumstance however, mean NDVI values derived from individual pixel values in each sample polygon and charted in Figure 13 indicate a clear shift in chlorophyll-a concentration at concrete to natural riverbed transitions.
